# **FIRE PATTERN PERSISTENCE AND PREDICTABILITY DURING FULL SCALE COMPARTMENT FIRE TESTS AND THE USE FOR COMPARISON OF POST FIRE ANALYSIS**

Ronald L. Hopkins, MS, CFEI, CFPS  
TRACE Fire Protection and Safety, USA

Gregory Gorbett, MS, CFEI, CFPS, MIFireE, IAAI-CFI  
Eastern Kentucky University, USA

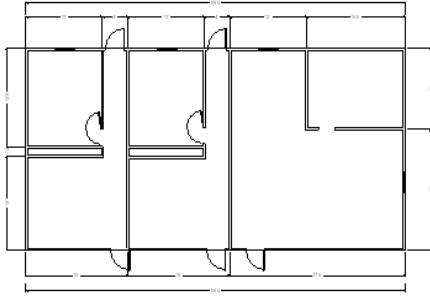
**Figure 1: layout of EKU test burn building**

The test facility, which opened during the Fall Semester, 2003 was specifically designed and built to afford students enrolled in the Fire and Safety Engineering Technology Programs, Fire, Arson and Explosion, Investigation option the ability to have access to “hands on laboratories” to investigate fire and explosion events. The test facility has two identical cells and a third cell that can be configured to specific sizes and layout as needed. (See Figure 1)

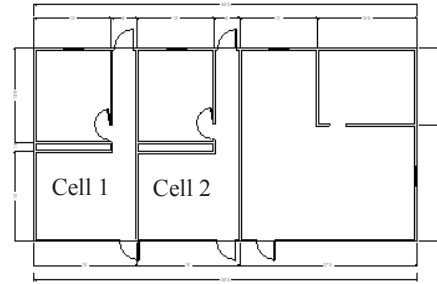
**Figure 2: location of test cells**

The test cells for this research project encompassed the north half of the facility configured into two identical 4.88 m by 9.75m (16' by 32') cells (see figure 2). The cells were constructed of 8" poured, reinforced concrete walls, which were lined with 2x4 studs and gypsum wallboard (See Figure 2). All dimensions are approximated. (See Figure 2)

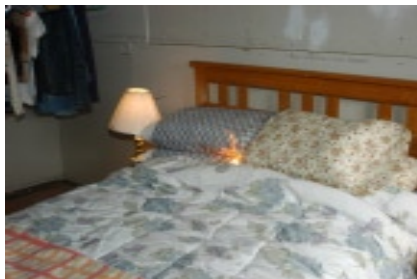
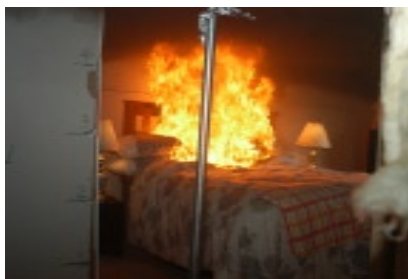
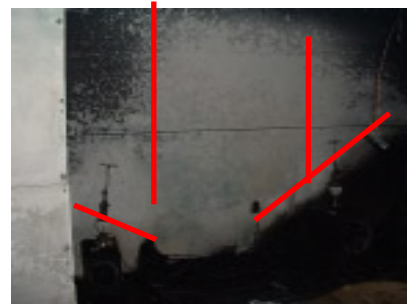
### Experiment Set A: Experiment 2

In cell #1 (experiment #1), the technical indicator of 600°C (1112°F) in the upper layer for flashover was achieved at approximately 330s (seconds). The duration of the post-flashover/fully involved stage of the fire, the time between flashover and suppression, for experiment #1 was 360 s. In cell #2 (experiment #2), the technical indicator for flashover of 600°C (1112°F) in the upper layer was achieved at approximately 190s. The duration of the post-flashover/fully involved stage of the fire for experiment #2 was 200s.

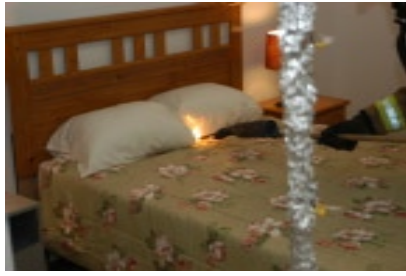
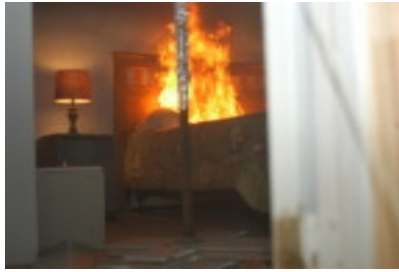
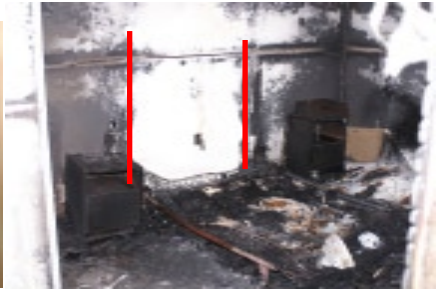
**Experiment Set C: Experiment 6**

The test in cell #1 (experiment #5) was stopped early due to hazardous weather conditions creating an unsafe work environment. In experiment #5, the technical indicator for flashover of 600°C (1112°F) in the upper layer was achieved at approximately 1396s (seconds). However, the full transition of flashover into full-room involvement did not occur. This was evident from the radiometer readings, as well as the post-fire inspection of the furnishings. In cell #2 (experiment #6), the technical indicators for flashover of 600°C (1112°F) in the upper layer and radiant flux of 20kW/m<sup>2</sup> at the floor were achieved at 790s. The duration of the post-flashover/fully involved stage of the fire for experiment #6 was 215s.

As a note, initially, the researchers involved in this project were concerned that Experiment 5 was stopped early in the fire. However, by extinguishing the fire prematurely, we were able to examine the fire patterns that were developed just prior to the room transitioning to full room involvement and if the fire pattern did persist post flashover. They did and the resemblance was remarkable.

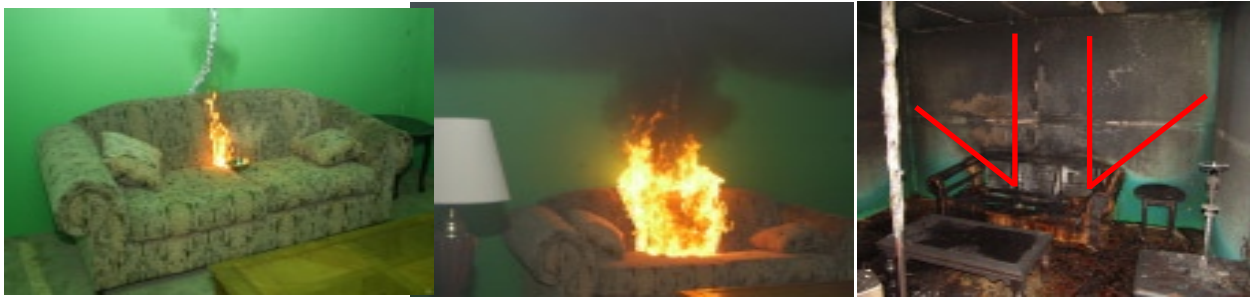
Experiment Set B: Experiment 3

In cell #1 (experiment #3) the technical indicator for flashover of 600°C (1112°F) in the upper layer was achieved at approximately 236s (seconds). Also, in experiment #3, the duration of the post-flashover/fully involved stage of the fire was 124s. In cell #2 (experiment #4) the technical indicator for flashover of 600°C (1112°F) in the upper layer was achieved at approximately 212s. Also, in experiment #4, the duration of the post-flashover/fully involved stage of the fire was 120s. The temperature growth profiles from experiments #3 and #4 are almost identical.

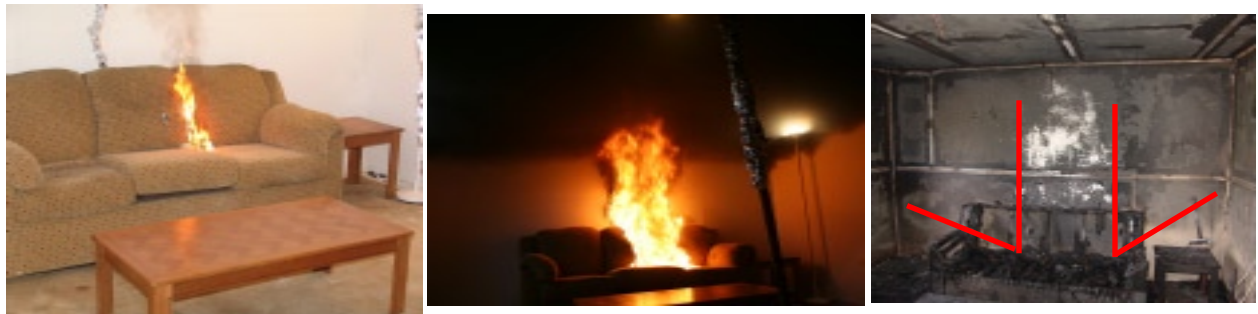
Experiment Set D: Experiment 7

In cell #1 (experiment #7) the technical indicator for flashover of 600°C (1112°F) in the upper layer was achieved at approximately 640s (seconds). Also, in experiment #7, the duration of the post-flashover/fully involved stage of the fire was 194s. In cell #2 (experiment #8) the technical indicator for flashover of 600°C (1112°F) in the upper layer was achieved at approximately 488s. Also, in experiment #4, the duration of the post-flashover/fully involved stage of the fire was 216s.

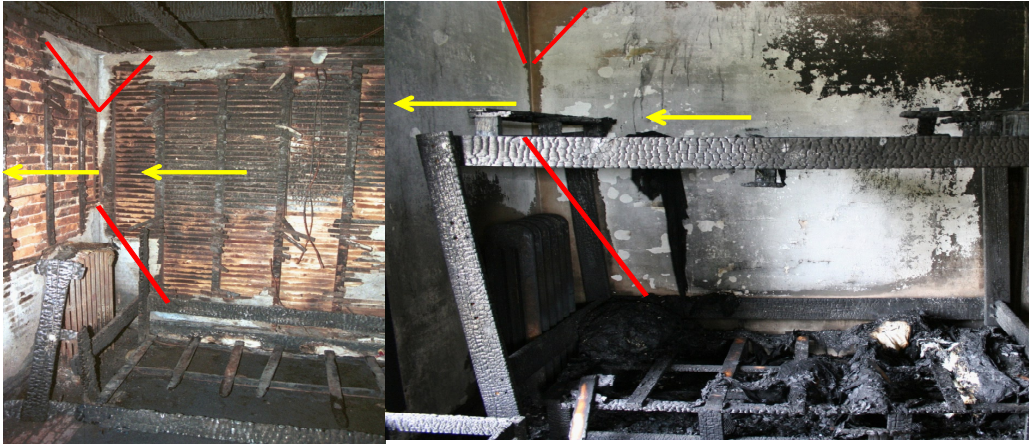
### South Wall

Actual fire on the left, test fire on the right

Due to the length of the paper, complete results of the Depth of Calcination and Heat and Flame Vector analysis cannot be reported. There were several areas within the compartment where there was calcinations of the plaster and in some locations part of the skim coat of plaster disassociated from the base coats. In the area of the bed and ceiling above, the full thickness of the plaster calcined and started to disassociate from the lath.

Since the original fire scene was not available to compare the results of the test, the researcher's utilized data gathered from the test fire and then compared those results to fire scene photographs taken at the time of the fire and by subsequent fire investigators. This comparison is utilized as the final analysis step. While the fire patterns developed in the test fire are not exact, they are within acceptable parameters to matching those in the actual fire. The fire patterns in the test fire were similar to those in the actual fire, but they did not progress and transition as far as the actual fire due to the length of the burn. The total burn time of the actual fire was not known, however, based on the fire scene photographs it is recognized

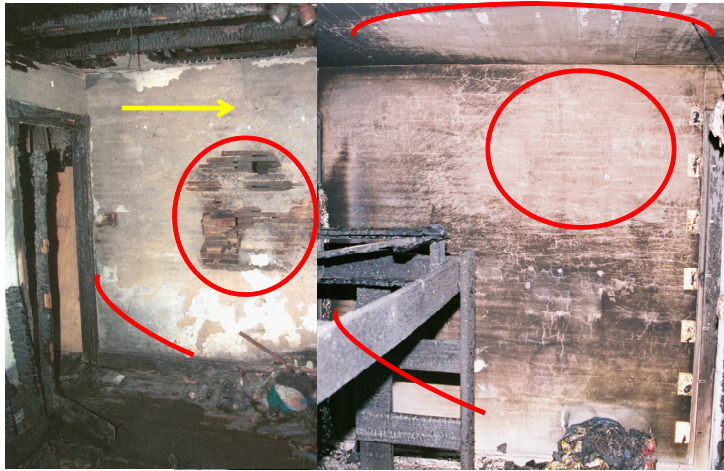
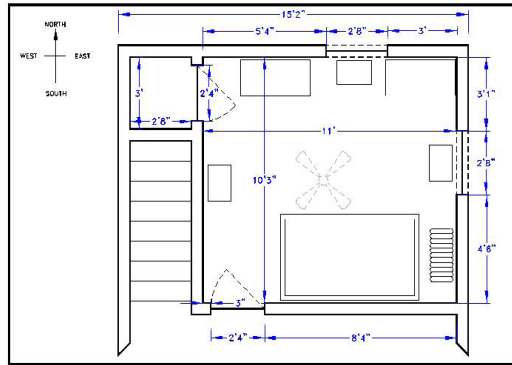
# West Wall

Actual fire on the left, Test fire on the right
